**DEPARTMENT OF TRANSPORTATION****DIVISION OF ENGINEERING SERVICES**

Contract #: 04-0120F4Cty: SF/ALA Rte: 80 PM: 13.2/13.9File #: 69.28**WELDING INSPECTION REPORT****Resident Engineer:**Siegenthaler, Peter**Address:** 333 Burma Road**City:** Oakland, CA 94607**Report No:** WIR-018789**Date Inspected:** 02-Dec-2010**Project Name:** SAS Superstructure**OSM Arrival Time:** 1900**Prime Contractor:** American Bridge/Fluor Enterprises, a JV**OSM Departure Time:** 700**Contractor:** Zhenhua Port Machinery Company, Ltd (ZPMC), Changxing Island **Location:** Shanghai, China**CWI Name:** See Below**CWI Present:** Yes No**Inspected CWI report:** Yes No N/A**Rod Oven in Use:** Yes No N/A**Electrode to specification:** Yes No N/A**Weld Procedures Followed:** Yes No N/A**Qualified Welders:** Yes No N/A**Verified Joint Fit-up:** Yes No N/A**Approved Drawings:** Yes No N/A**Approved WPS:** Yes No N/A**Delayed / Cancelled:** Yes No N/A**Bridge No:** 34-0006**Component:** OBG**Summary of Items Observed:**

OBG Bay 14

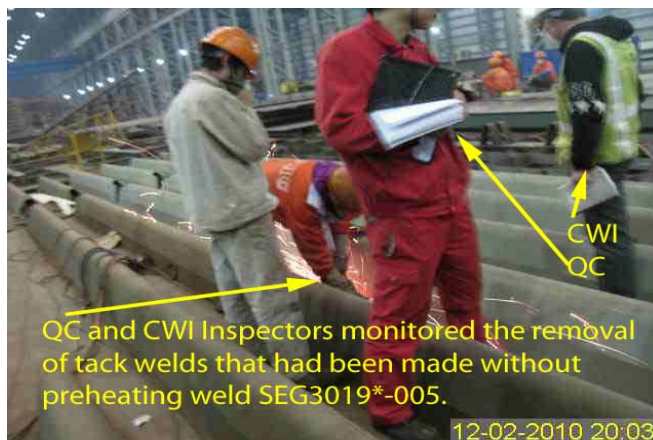
This QA Inspector observed ZPMC welder Mr. Sun Lingling, stencil 048047 used shielded metal arc welding procedure WPS-B-P-2212-B-U2-FCM-1 to make OBG tack weld SEG3019\*005 between segment 14E deck plates. This QA Inspector observed Mr. Sun Lingling did not appear to have preheated the base materials prior to making a tack weld near the center of this weld joint. This QA Inspector observed the ambient steel temperature was less than 20 degrees Celsius. This QA Inspector observed that the minimum preheat for his weld joint is 40 degrees Celsius. This QA Inspector informed ZPMC QC Inspector Mr. Guo Wei and Mr. Zhong Guo Hui that no preheating of the base materials appears to have been used prior to tack welding. This QA Inspector asked Mr. Guo Wei who was the responsible Certified Welding Inspector (CWI) for this welding and he informed this QA Inspector the CWI for this location was Mr. Li Yan Hua. This QA Inspector asked QC Inspectors Mr. Guo Wei and Mr. Zhong Guo Hui to have the CWI come to this location in order to observe the lack of preheat. About fifteen minutes later ABF CWI Mr. Li Shi You arrived at the weld (instead of CWI Mr. Li Yan Hua) and Mr. Li Shi You said he was the CWI for the West lift 13 and 14 and he was not assigned to perform inspections on the

East lifts 13 and 14. Mr. Li Shi You spoke with Mr. Sun Lingling and he informed this QA inspector that only two tack welds were made without preheat. Mr. Li Shi You had the welds ground out and he marked these areas to be magnetic particle (MT) inspected at a later time. Mr. Li Shi You said there were no MT Inspectors available to perform the MT inspections this shift. See the photographs below for additional information.

ZPMC did not preheat the base material prior to making tack welds in SEG3019\*-005.
